## Aviation Safety

# Maintainer

Issue 3/2003

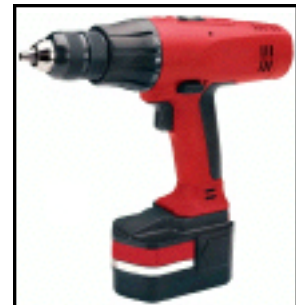
A case in point: A maintenance technician had removed a Cessna 421C wing fuel tank access panel in order to carry out the replacement of a fuel valve located inside the fuel tank. As he proceeded to remove some of the fasteners inside the fuel tank, a spark from his cordless screwdriver ignited the fuel vapours remaining in the tank. The explosion was so violent that the maintenance technician lost his life and the aircraft was substantially damaged. The investigation revealed that the failure to purge all fuel and fumes from the fuel tank, coupled with the fact that the cordless screwdriver was not certified explosion-proof, led to the accident. In another recent accident, an aircraft maintenance

engineer (AME) was removing a helicopter fuel tank access panel while there was still a small amount of fuel remaining in the tank. As the screws were being removed, fuel dripped onto the portable screwdriver and ignited

the fuel and the fuel tank. Fortunately, through prompt action of co-workers with quick access to fire extinguishers, the fire was put out and the helicopter saved. Unfortunately, the engineer suffered third degree burns. In another incident, a complete aft turbine engine exhaust pipe module fell off the aircraft in flight. It is thought that fasteners weren't tightened to specifications. Cordless screwdrivers are very handy but you, professional AMEs, are responsible to ensure that their performance meets aircraft environment conditions. Ensure that your cordless screwdrivers are on the calibration list of special equipment that need monitoring. The aircraft fasteners torque requirements are those found in the respective aircraft maintenance manual. The calibration process may be obtained by contacting organizations that offer such services and that are recognized by an international body such as the American Society for Testing and Materials (ASTM International). Don't screw up your work and your life too! 📌
